ALDER MARSH DAM

NDI ID No. PA-00153  
 DER ID No. 64-150

PENNSYLVANIA GAME COMMISSION

PHASE I INSPECTION REPORT  
 NATIONAL DAM INSPECTION PROGRAM

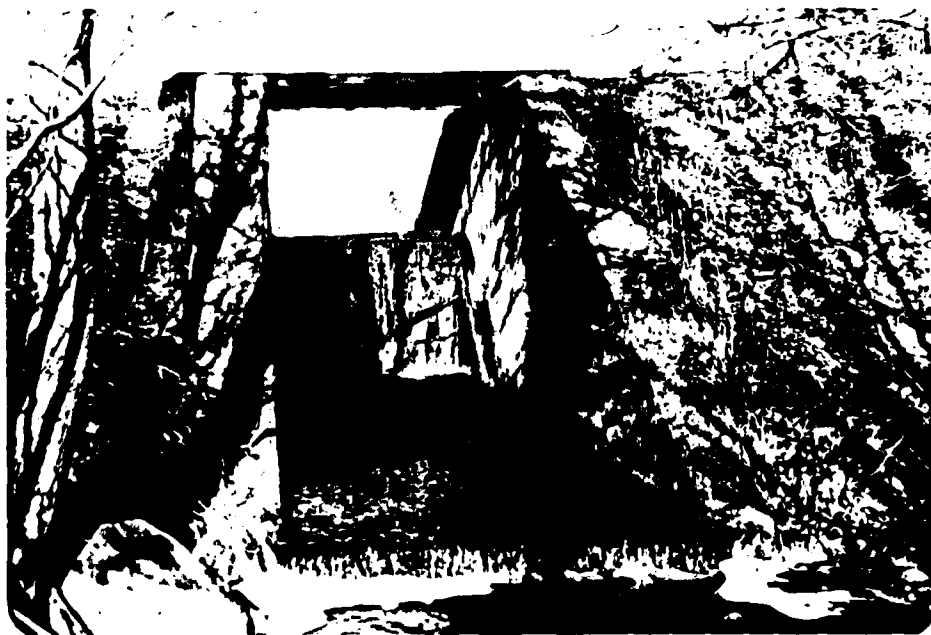
D. Downstream Side of Principal Spillway
